# Gravity Sewer and Water Main Rehabilitation and/or Replacement, Phase 1

## Preliminary Design Report

TWA Project No. 16-060

**Toho Water Authority**  
951 Martin Luther King Jr. Boulevard  
Kissimmee, FL 34741

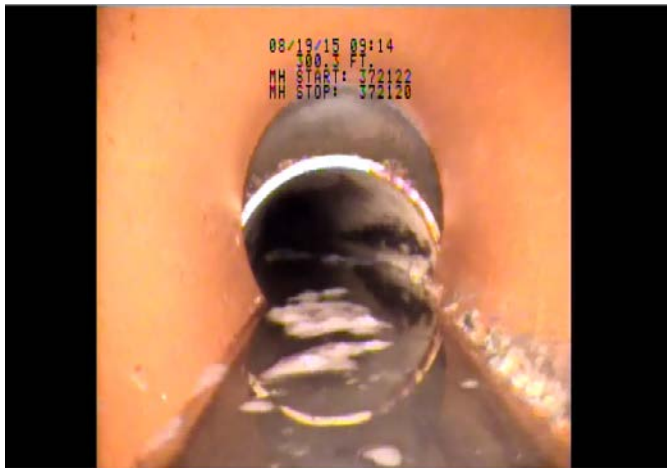
A total of 17 spot repairs are needed to replace some severely offset pipe connections at what appears to have been multiple manholes that settled after construction. It was common to have VCP sewers in fair condition that have 30-50% pipe offsets at the flexible connections to the PVC piping connecting to these manholes. In cases where the offset was severe, the repair will require the replacement of these manholes to correct the grade issues.

Offset MMC

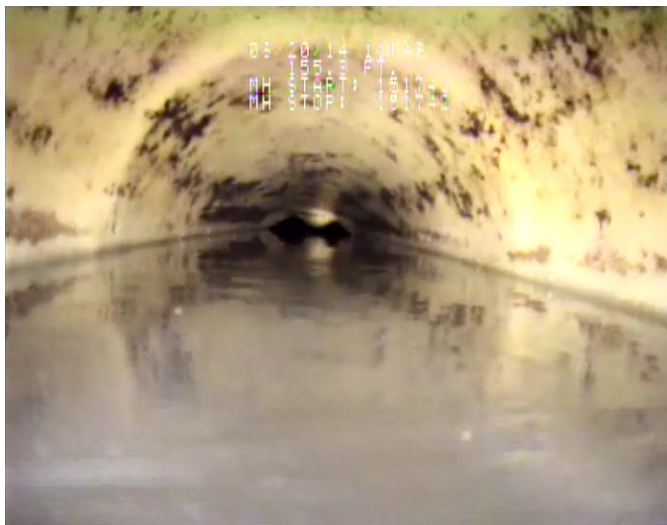
One segment of sewer along San Remo Road has multiple full pipe sags that will require replacement of the sewer.

Full Pipe Sag

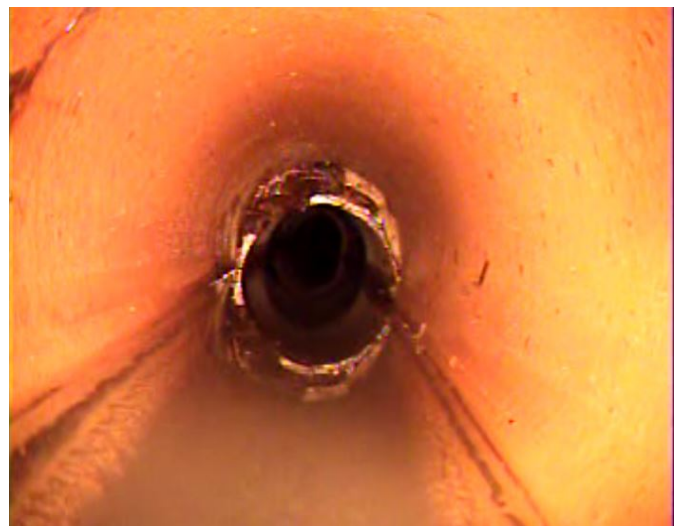
Offset VCP Joint

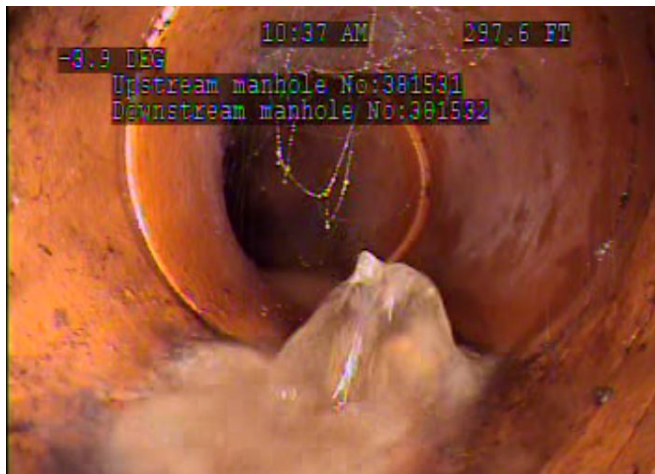
Gushing I/I at Broken Lateral

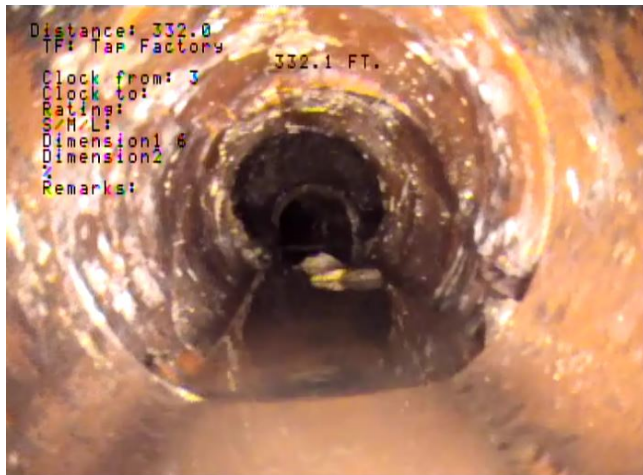
Fractured Pipe

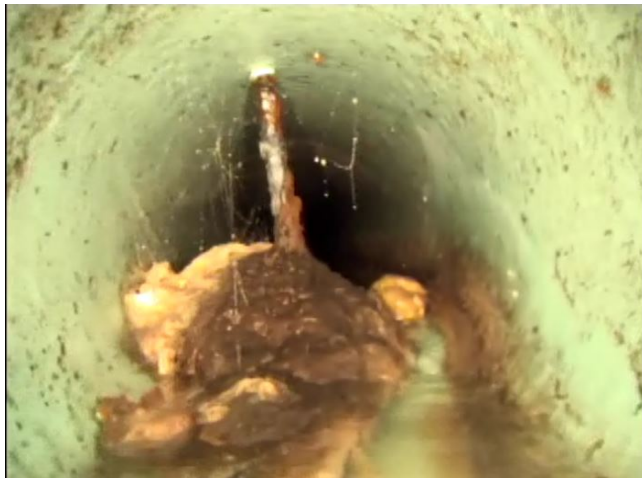
Pipe Obstacle

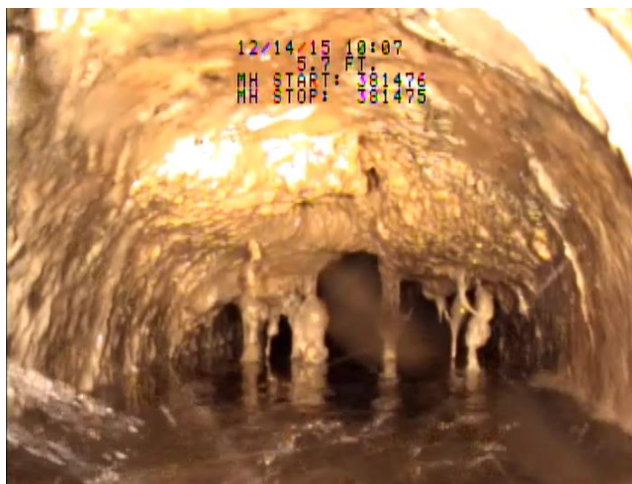
Grease in Sagging Pipe

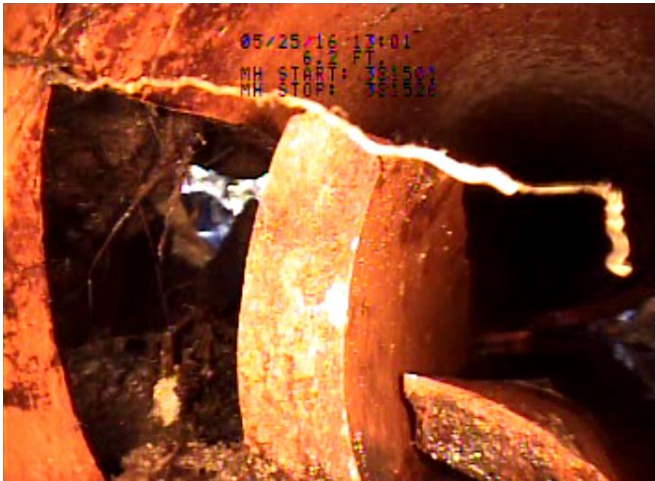
## Broken Pipe at Drop Connection

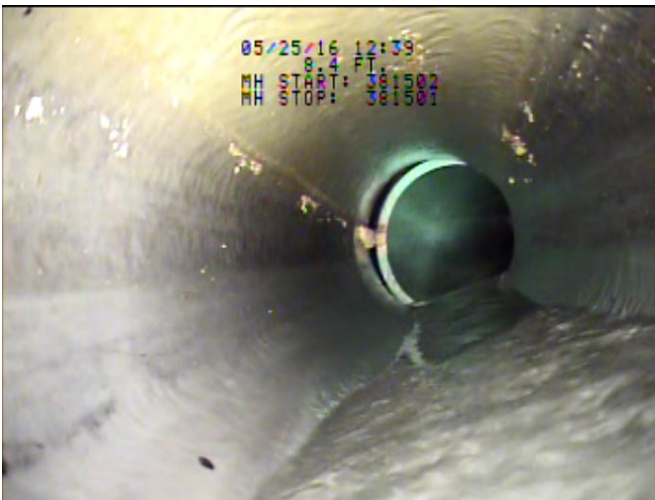
### Offset PVC Connection to Lined Pipe

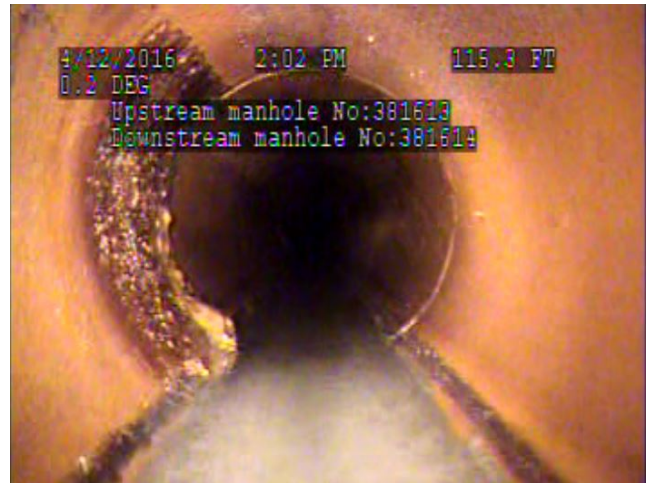
Longitudinal Fracture

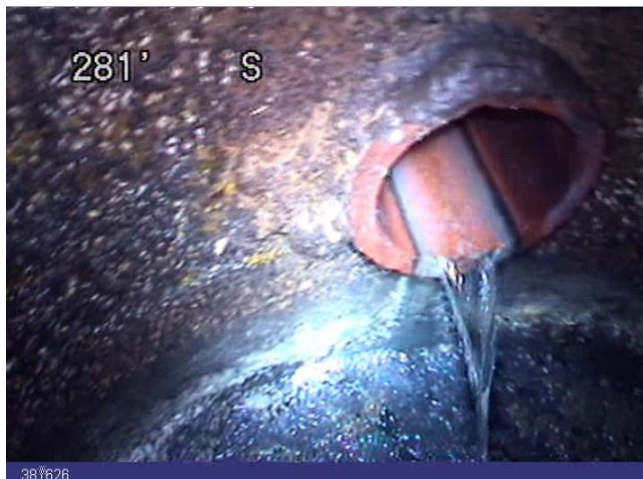
MH Wall Condition

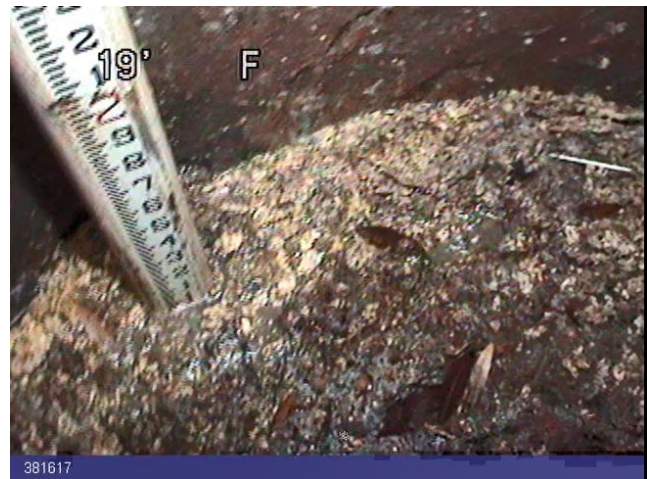
MH on Uninspected Pipe

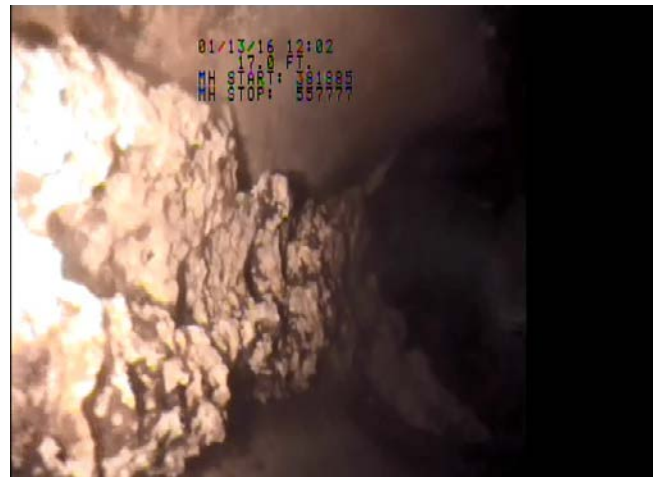
Attached Grease Going Into Sag

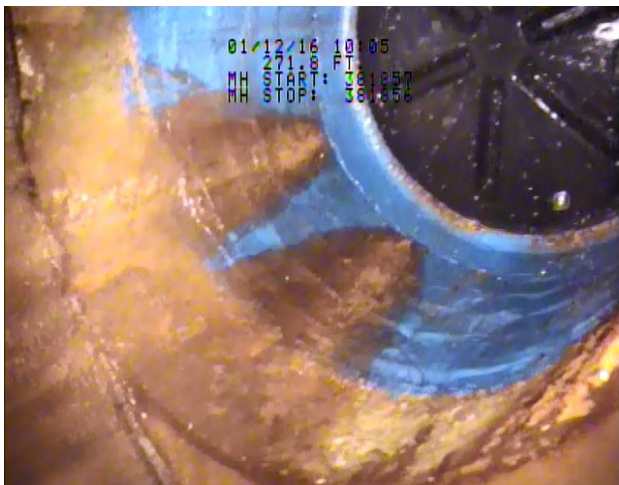
Leaking Chimney Seal

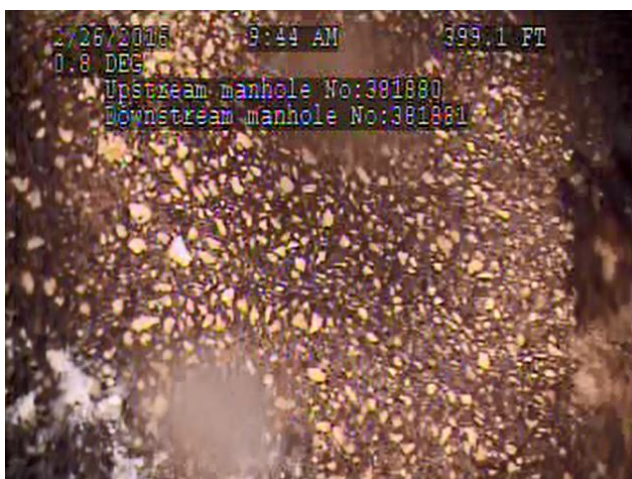
Drop MH Wall Condition

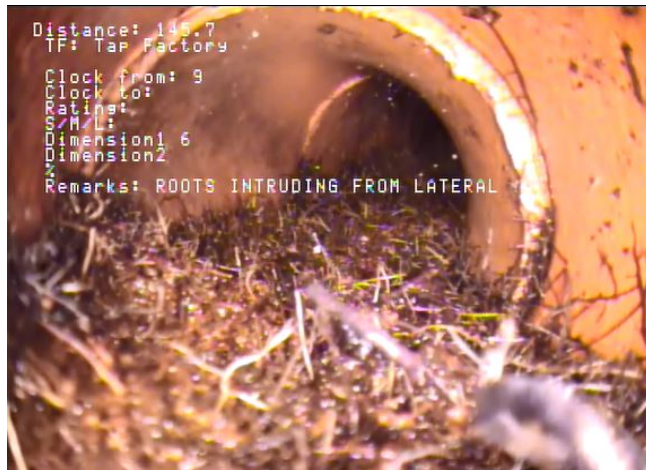
Roots in Lateral

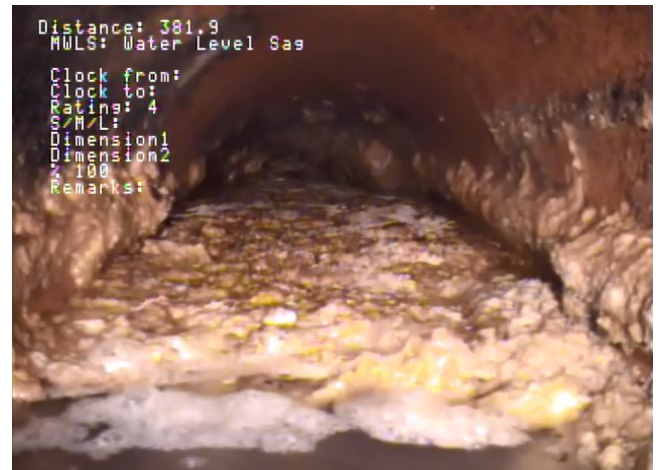
Attached Grease Going Into Sag

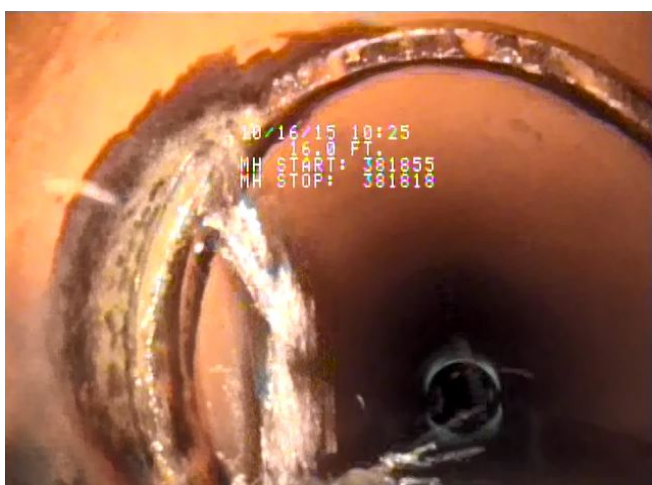
Gushing Infiltration

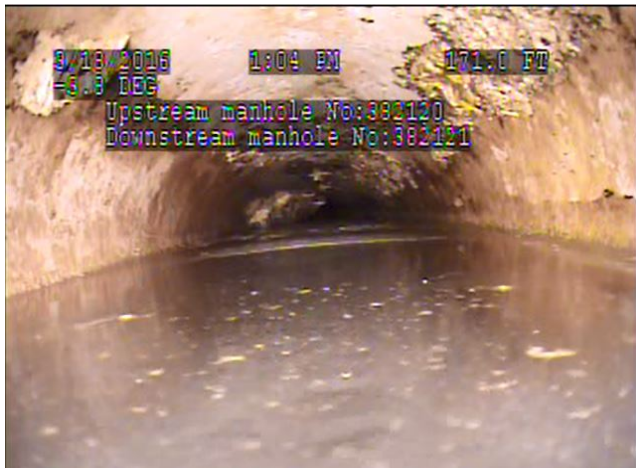
Full Pipe Sag

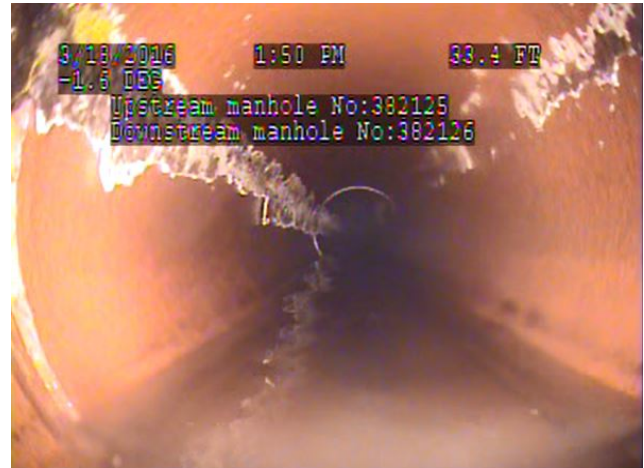
Attached Grease on Pipe Walls

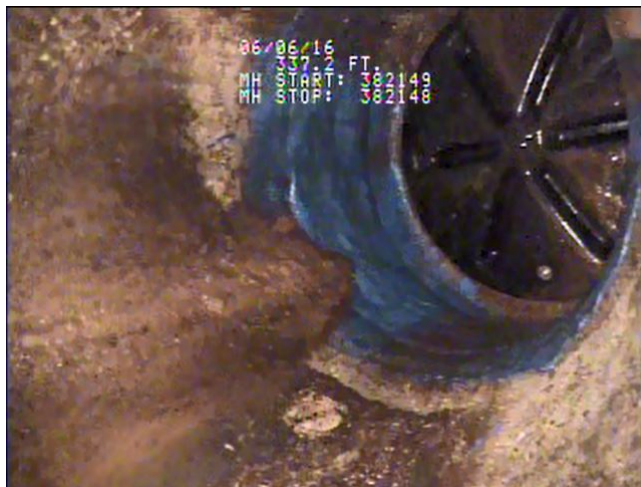
Leaking Chimney Seal

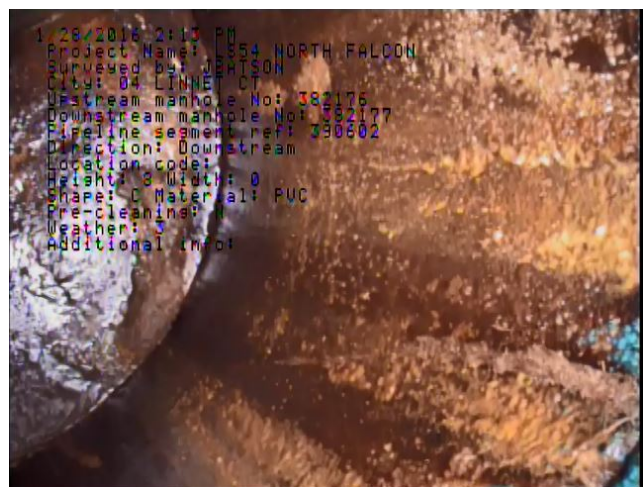
Significant MH I/I

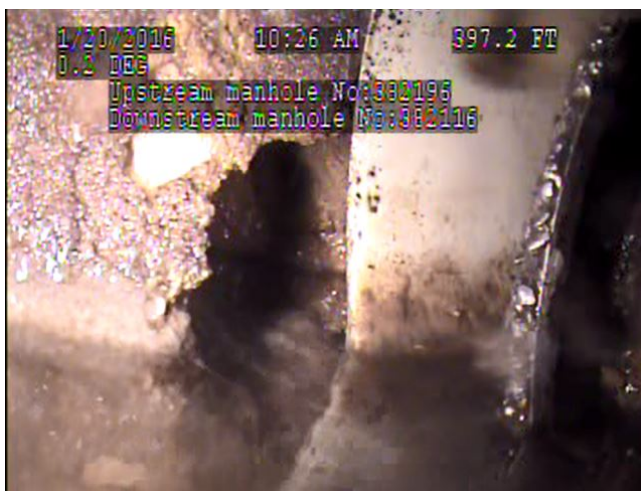
Missing Pipe Connection Seal at MH

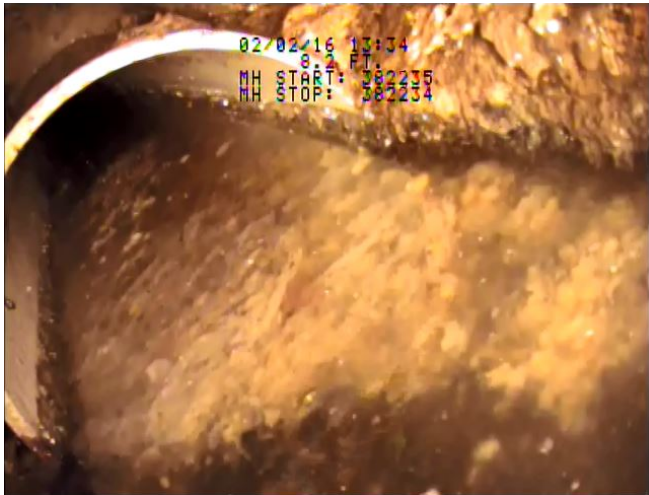
Pipe Full of Sludge

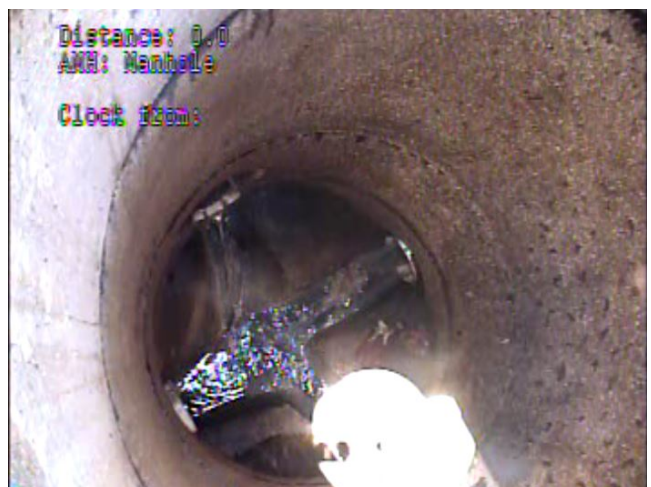
Typical Manhole Condition

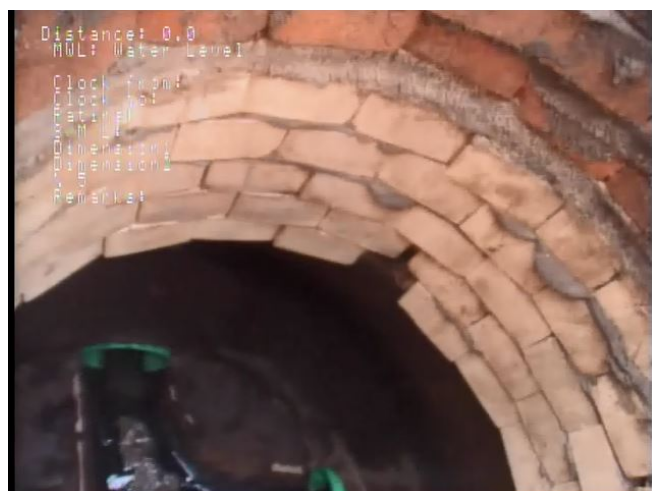
### Typical MH Chimney Condition

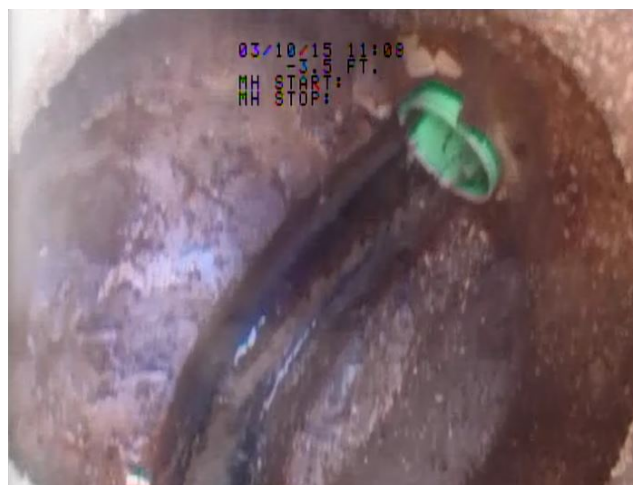
Corroded MH

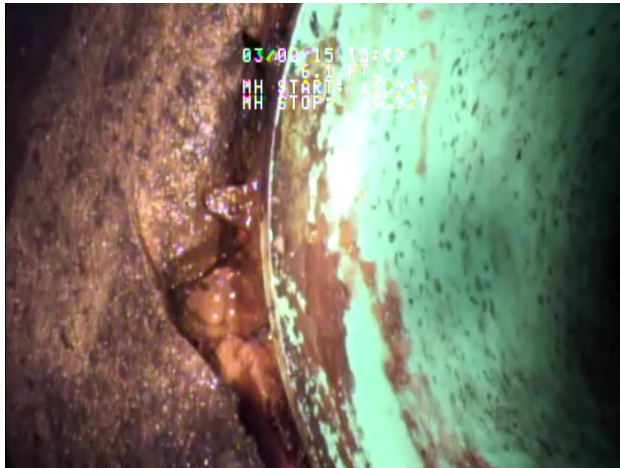
Pipe Connection in MH to be Sealed

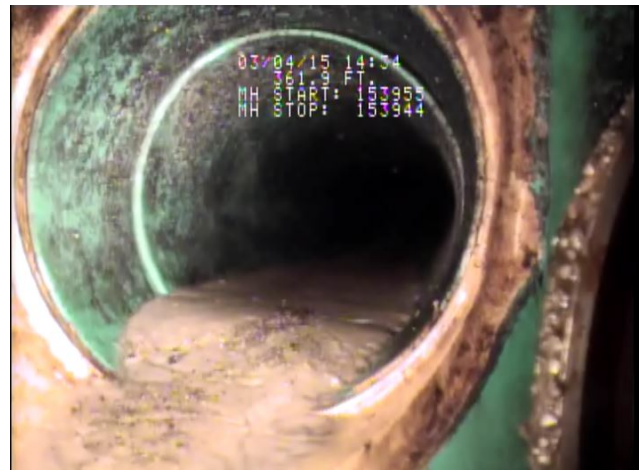
Silt in Lateral, no Visible Defect

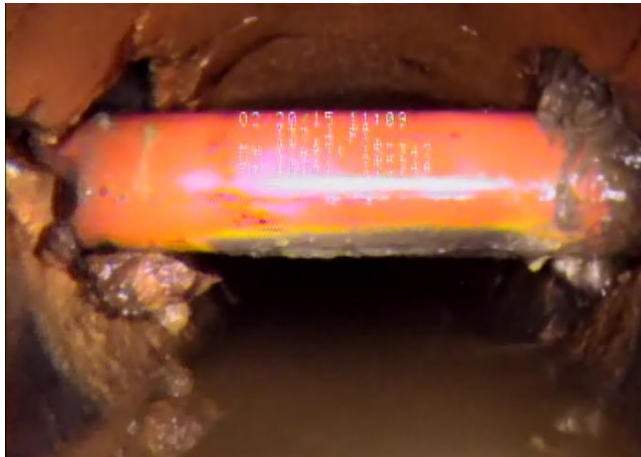
Cross Bore Through Pipe

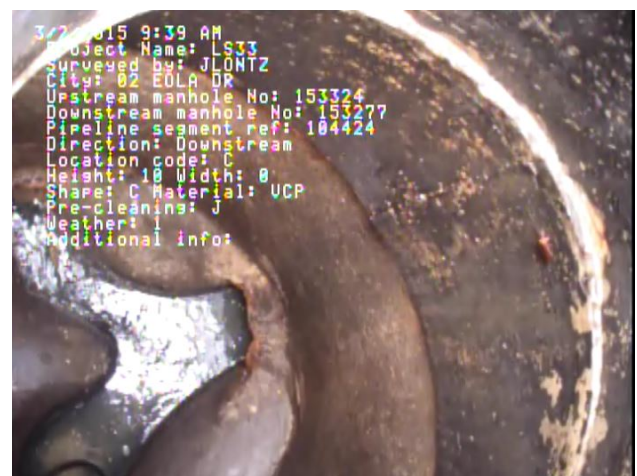
Typical Manhole Condition

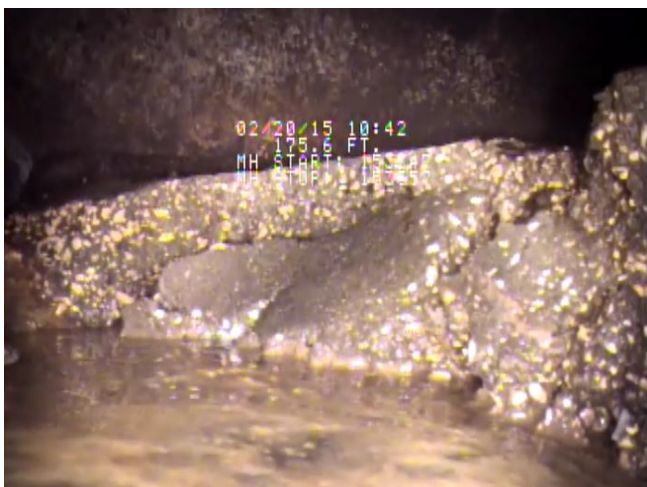
Crumbling MH Bench

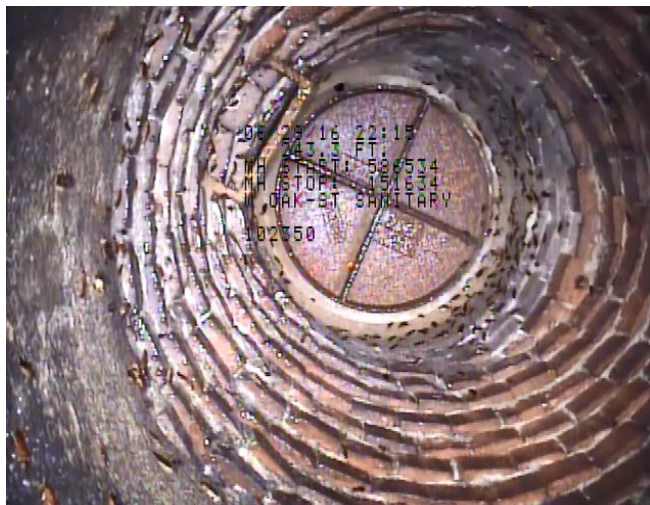
Brick Manhole Chimney

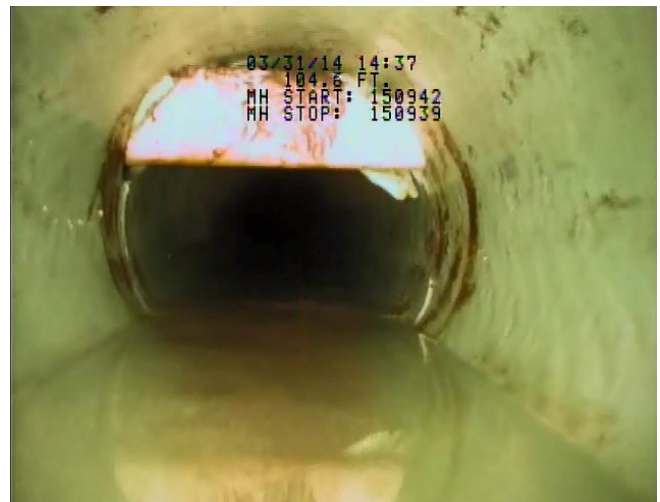
Utility Cross Bore

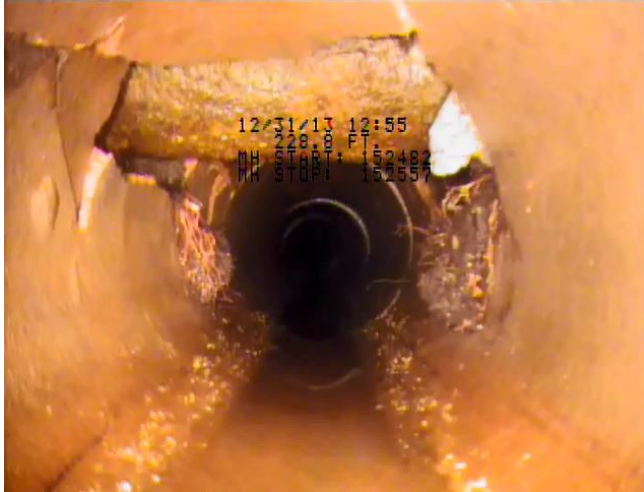
Potential Conflict Pipe

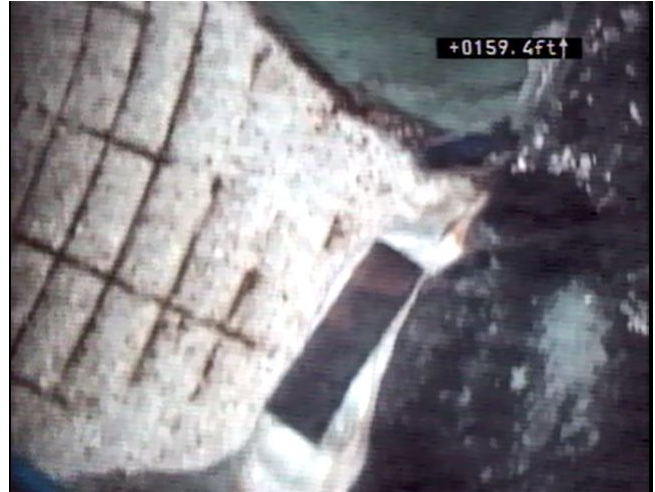
Precast Manhole Reinforcement

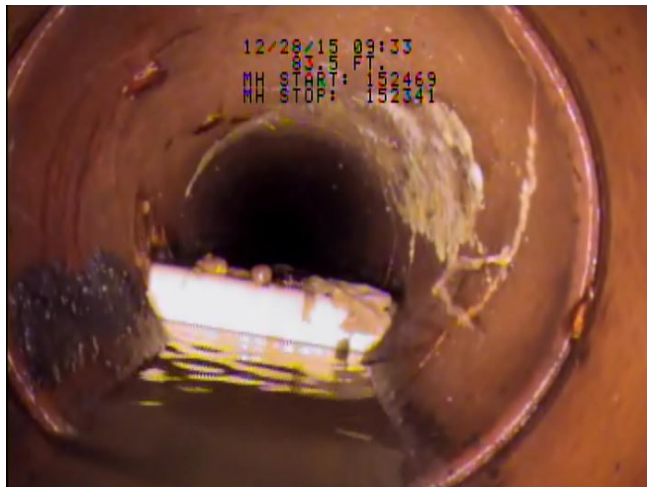
Utility Cross Bore

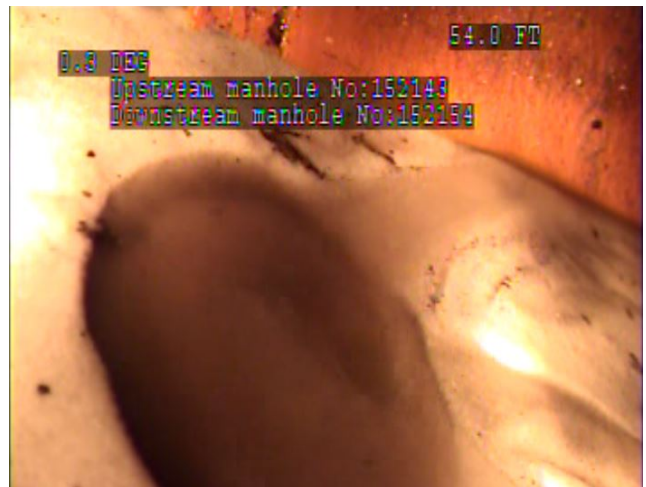
Gushing I/I with Sand in Pipe

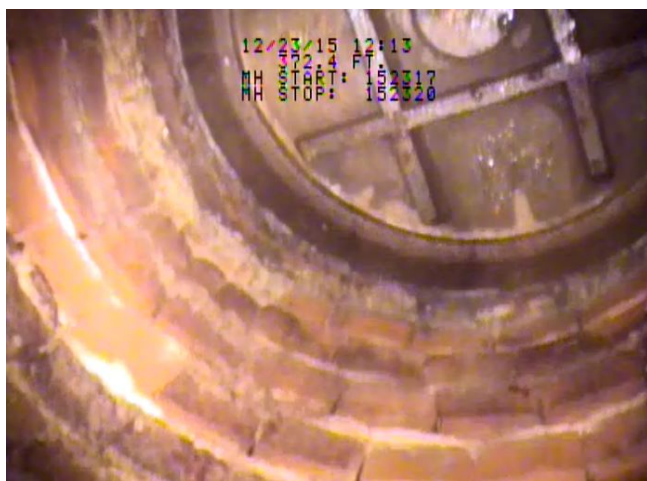
Typical Brick Manhole Condition

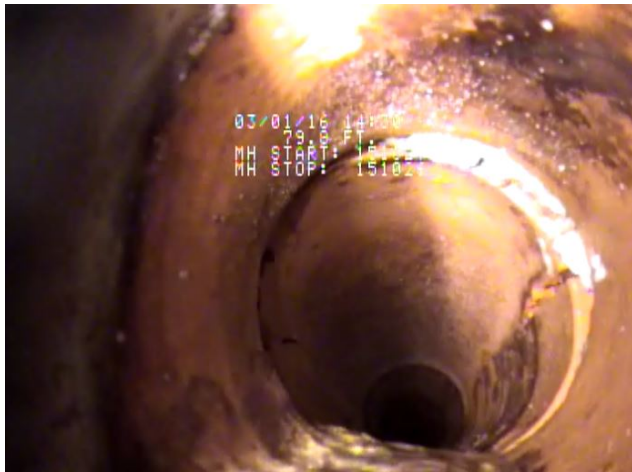
Fractured Lateral on Lined Main

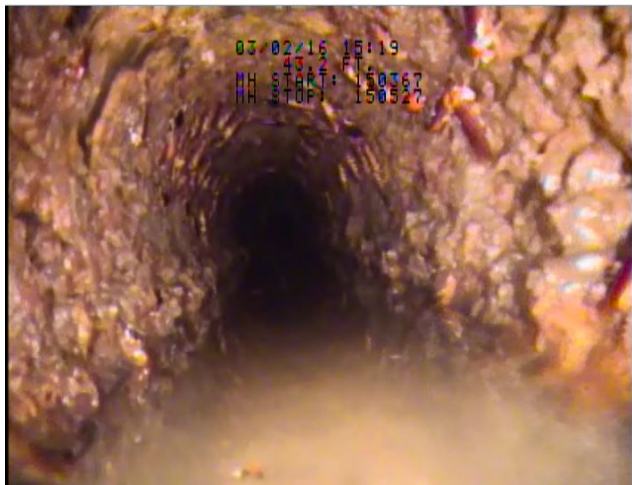
The PVC pipe is in very good condition, however there is one common defect where the pipe typically transitions to DIP under pavement and the DIP cement lining has fallen away and the metal pipe walls have scaled over causing a reduction in pipe diameter. There are 2 locations where it is recommended to clean off the buildup and install a spot liner to prevent further wall corrosion.

DIP Pipe Segment with Scale

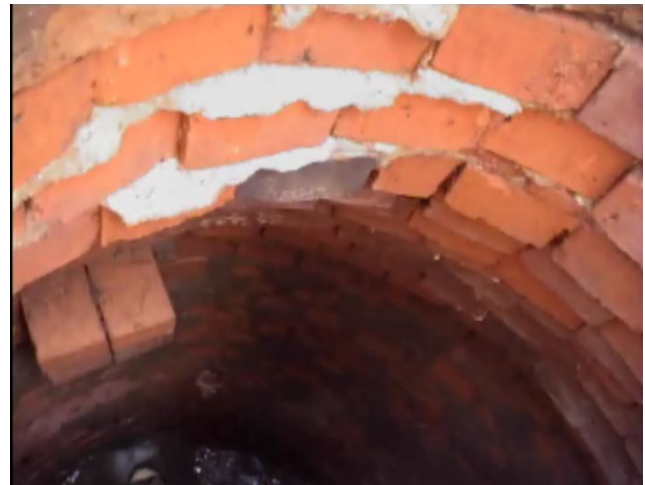
Typical MH Brickwork

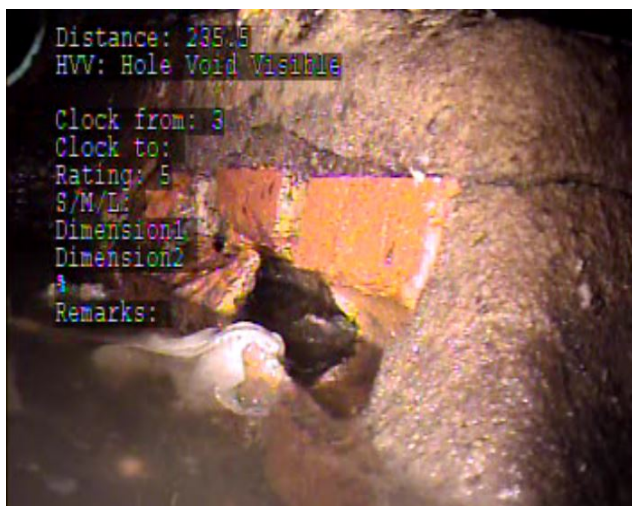
Missing Brick Flow Channel

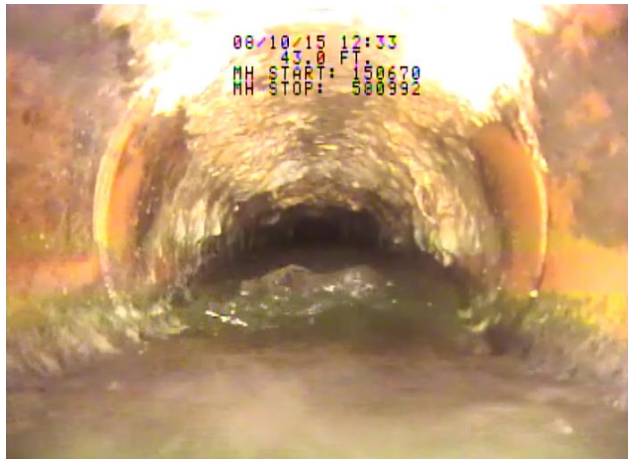
Grease on Sagging Pipe Crown

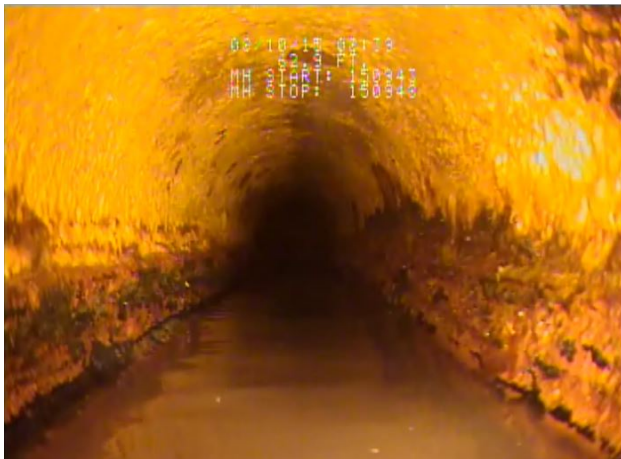
DIP Pipe Segment along Creek

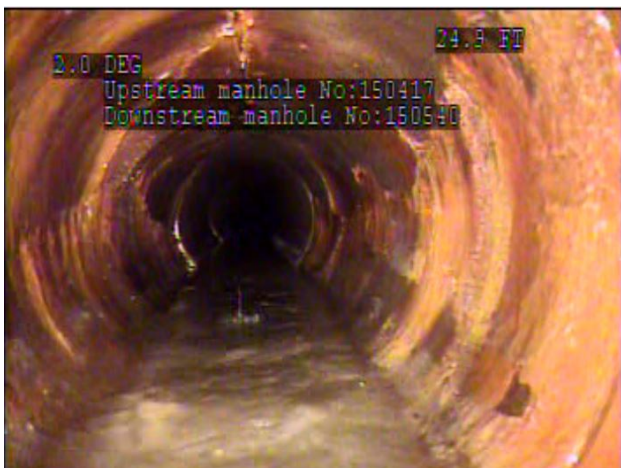
Hinge Fractures

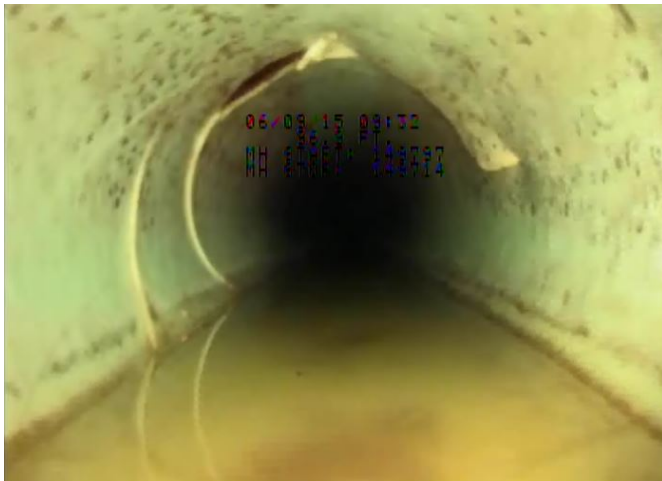
There is one PVC pipe segment with a small hole chipped out that should be repaired with a short spot liner.

Hole in PVC Pipe Crown

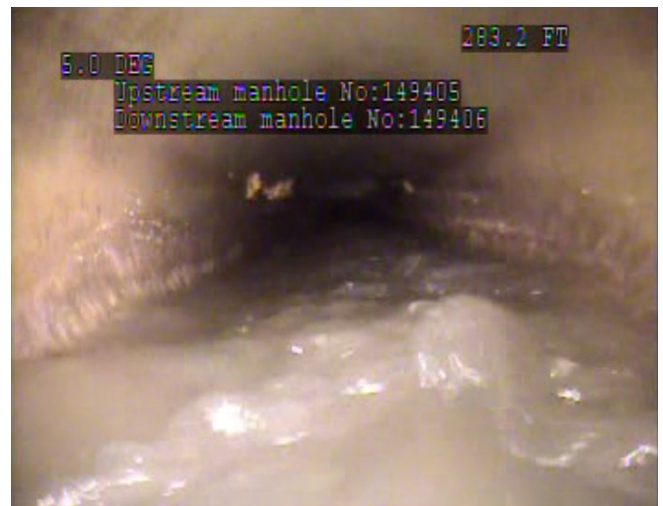
PVC Pipe Sag into Manhole

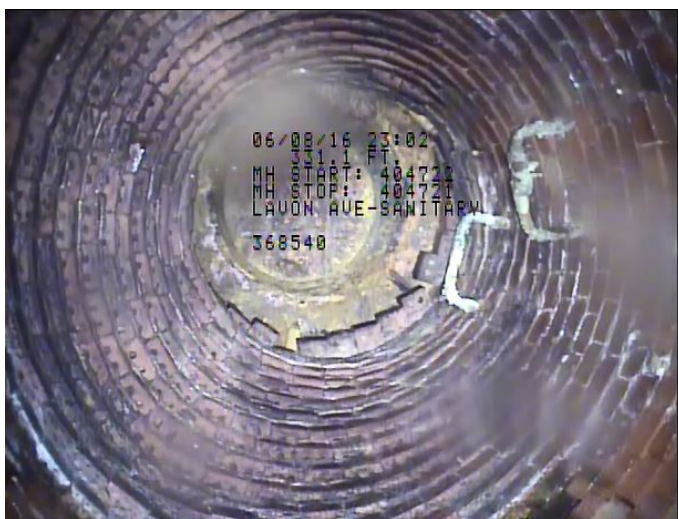
Brick Manhole Chimney

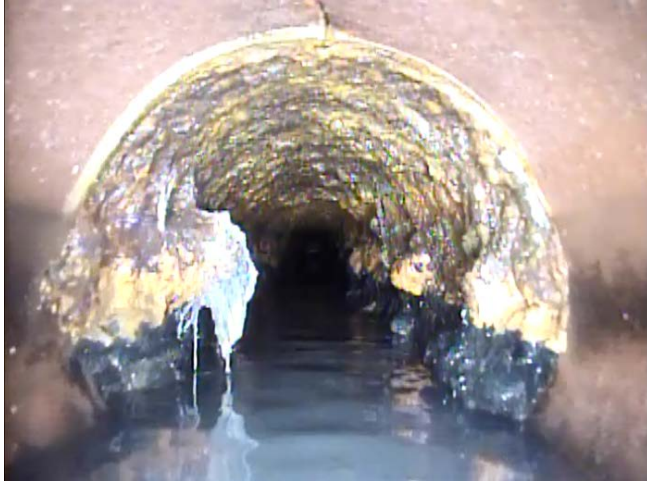
CI/DIP Pipe Section

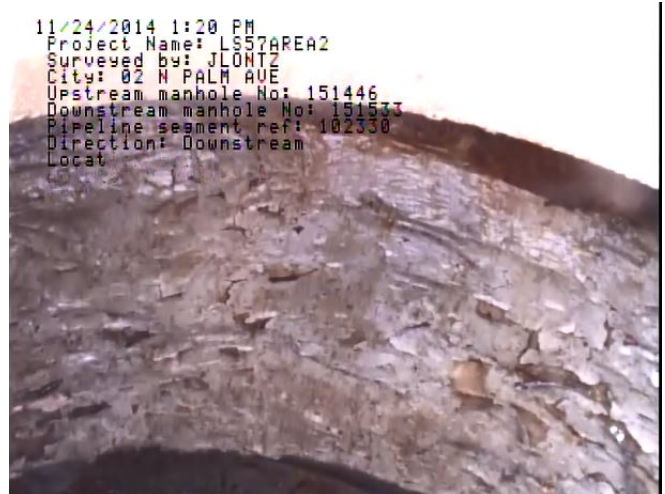
Chimney Seal Flaking Away

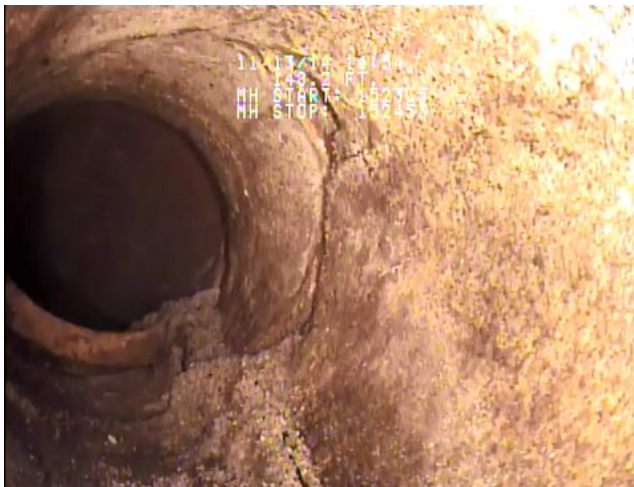
Concrete Pipe Broken Wye

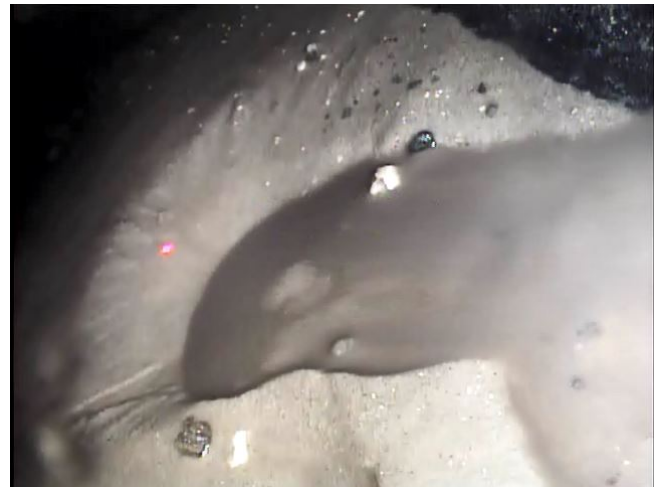
Sand Flowing into MH Channel with I/I

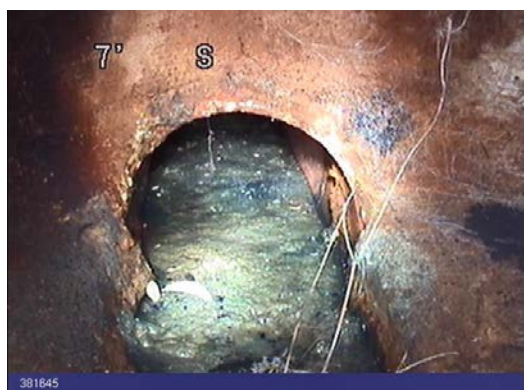
Figure 2- Pipe full of sludge/debris

Cleaning is to be recommended in the case where the pipeline is in good structural condition and does not require any repair work, but has enough debris/sludge/roots/grease in the pipe to be causing issues with the flow in the main. Pipeline with the above observations that also require structural repair will typically be cleaned as part of preparation of the structural repair work, so this would not need a redundant recommendation if the pipe were to be lined or have a spot repair.

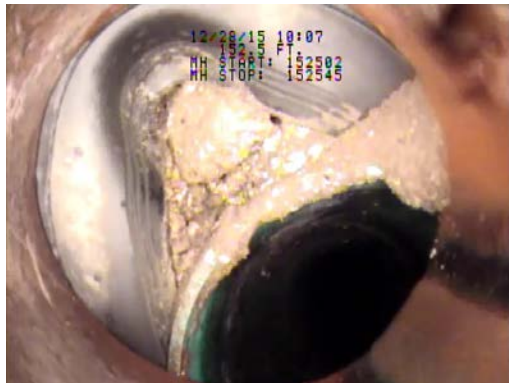
Figure 4- Offset joint

The majority of the gravity main is in good structural condition and there is an isolated defect such as a offset/failed joint or service tap, short unacceptable sags, obstacles penetrating through a pipe segment such as a bored gas main, failed flexible connectors, or any other short (preferably 20 feet long or less) continuous defects. In these instances, the overall pipe is found to be in good enough condition to where the overall line integrity after performing the repair will be satisfactory. See below for examples of some defects that may only require a spot repair to fix:

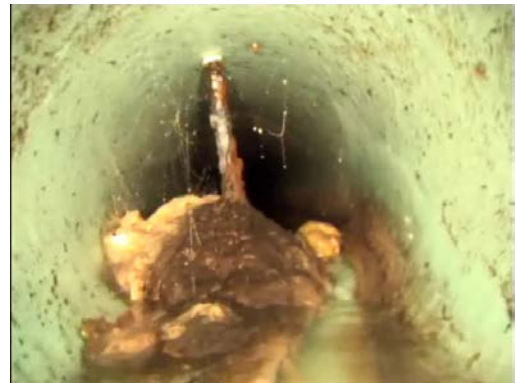
Figure 3 – Vertical Pipe penetration

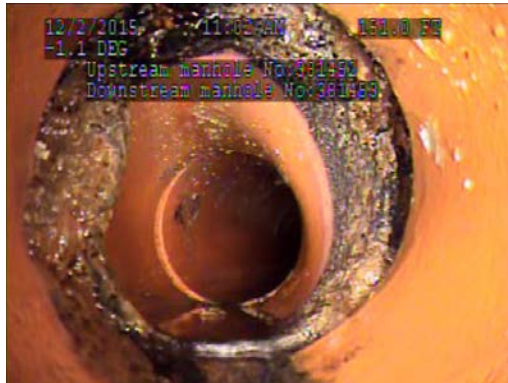
Figure 6- Offset lateral connection

The second circumstance is where the overall gravity main is in poor condition and may be a suitable candidate for lining, however there are certain defects that may prevent successful lining (offset joints, collapsing pipe, deformed pipe, protruding laterals or pipe penetrations, etc.) or certain defects that cannot be fixed through lining alone (pipe sags, services separated from the main, etc.). When these observations are made, a spot repair must be associated with the pipe that is recommended to be lined, and a comment added to perform spot repair prior to lining. Below are examples of defects that mainline CIPP lining cannot fix and may require a spot repair.

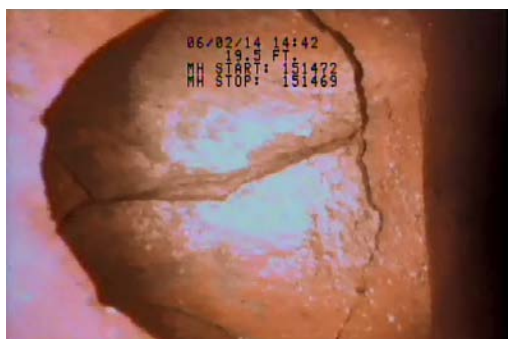
Figure 8- Fractured, intact lateral

Trenchless spot repairs are also included under this recommendation category. Mainline gravity main trenchless spot repairs would consist of a short segmental pipe liner, approximately 3 to 5 feet long (longer in some cases) and be used to address specific isolated defects such as joints with significant I/I, individual separated or broken pipe joints, pipe segments with holes, short segments of corroded DIP pipe, etc. If there is a problem at a service connection, either a sewer tap or wye connection where the integrity of either the mainline pipe or the lateral pipe is in question, then a lateral liner is recommended. It is quite common to have the main fracture due to the installation of the tap or from years of strain a tap may place on the main, leading to infiltration, debris, or root problems that can be solved through the installation of a lateral liner. Additional care must be taken when assessing a defective lateral for potential lining, as lateral liners can be difficult to install on connections that have any type of offset which may prevent the equipment from properly installing the liner. An improperly installed lateral liner may result in flow backups. See below for examples of defects that could be repaired with segmental or lateral liners.

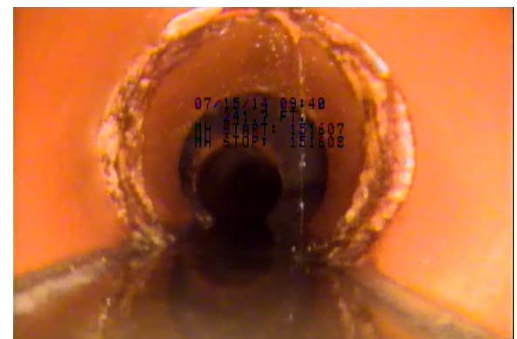
Figure 7 – Lone joint with running infiltration

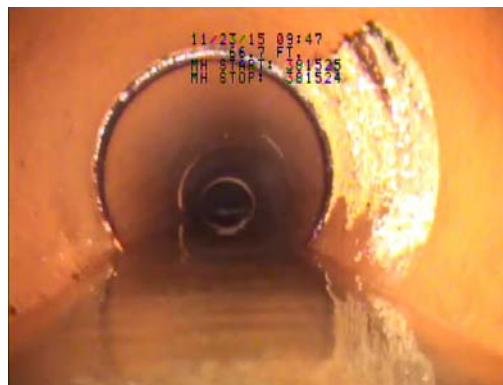
Vitrified clay pipe is a common pipe material found in the system, and is very prone to joint failure as the mains age, in particular if there is a high groundwater table. When joints begin to leak, the water brings fine soil particles into the sewer, eventually undermining the support around a pipe that can lead to greater failure, so it is wise to address pipelines that have poor joints that are leaking and beginning to offset before additional damage is done. Below are some examples of pipe defects that would warrant lining.

Figure 9 – VCP cracking

Cured-in-place-pipe (CIPP) lining is the most common form of sewer rehabilitation for gravity main collection systems. It is an ideal product to complete a full structural repair of a full reach of sewer with no, or minimal excavation. While typically used to counter against pipe with cracking/fracturing and other structural issues, it is also effective in extending the life of a gravity main that is exhibiting failing pipe joints.

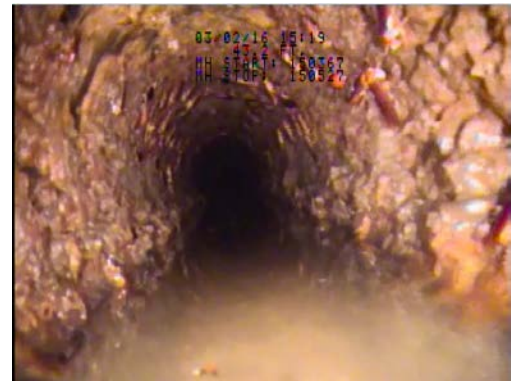
Figure 13 – Rust and scale in old iron pipe

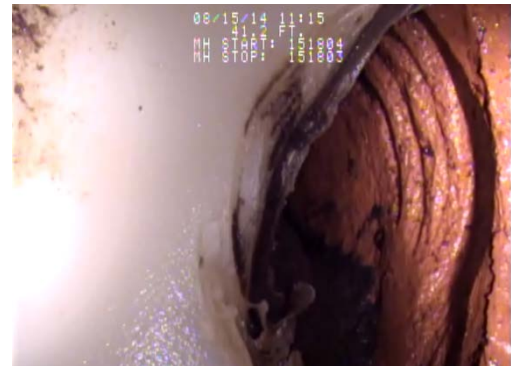
Figure 15 – Undercut CIPP lateral opening

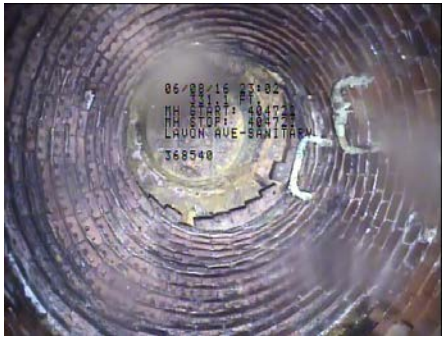
Figure 18- Brick MH, minor missing mortar

See below for some snapshots of manholes that will be sealed and coated.

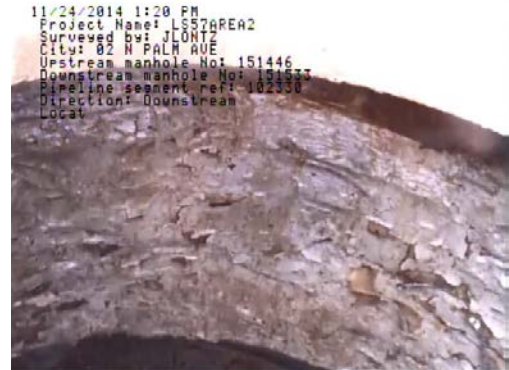
Figure 17 – Failing chimney seal.

Defective manhole chimneys are included to be covered under this recommendation. The products available for use in sealing manhole chimneys is consistent with the materials placed on the manhole walls. Where there are broken adjustment blocks and rings beyond the repair of patching, then the frame and cover of the manhole will be reset during construction prior to the trenchless coating to ensure full coverage of the end product. The resetting of the frame and cover will be determined during final design.

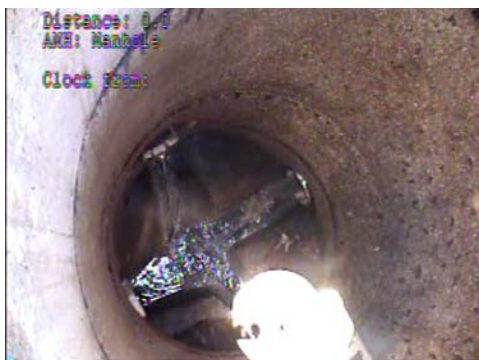
Figure 20- Minor concrete wall corrosion

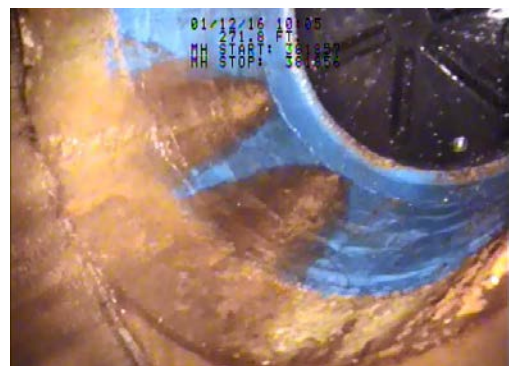
Figure 19 – Leaking chimney seal

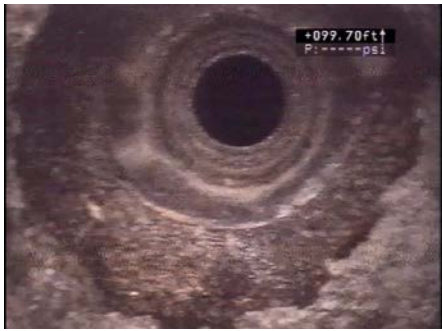
Figure 22- Excessive concrete manhole wall corrosion

When a brick or precast manhole shows signs of structural degradation and either no or only trenchless work to be done on the gravity main, manholes were recommended to be lined. In most cases these are deeper manholes along larger diameter sewers that have been subjected to H<sub>2</sub>S degradation of the concrete walls and mortar joints. Other defects that warranted a structural manhole liner included structural problems around pipe penetrations including issues at the flow channel. When extreme I/I conditions were observed and appeared to be too intense to repair through sealing and coating, a liner was recommended. See the snapshots below for examples of manhole that require structural lining.

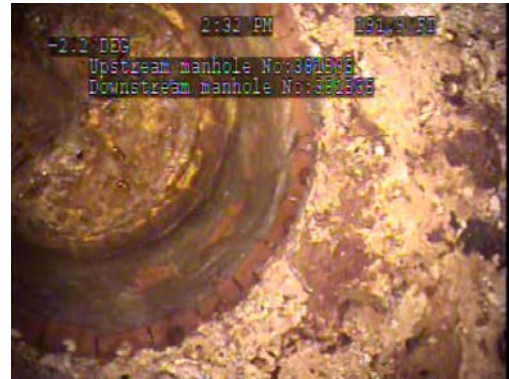
Figure 21 – Corroded manhole walls and lid.

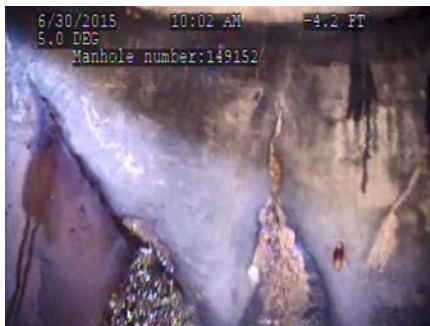
Figure 24- Fractured structure wall

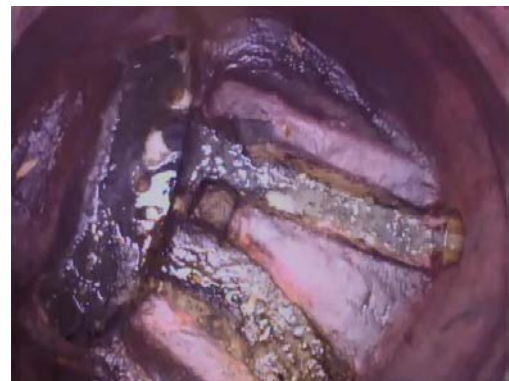
Figure 23 – Manhole with Spectrashield liner
